Test Report

No. : CE/2018/40394

Sample Submitted By : ELEKTRISOLA (MALAYSIA) SDN. BHD.
Sample Description : ELEKTRISOLA COPPER CLAD ALUMINUM BARE WIRE (CCA)
Sample Receiving Date : 2018/04/02
Testing Period : 2018/04/02 TO 2018/04/13

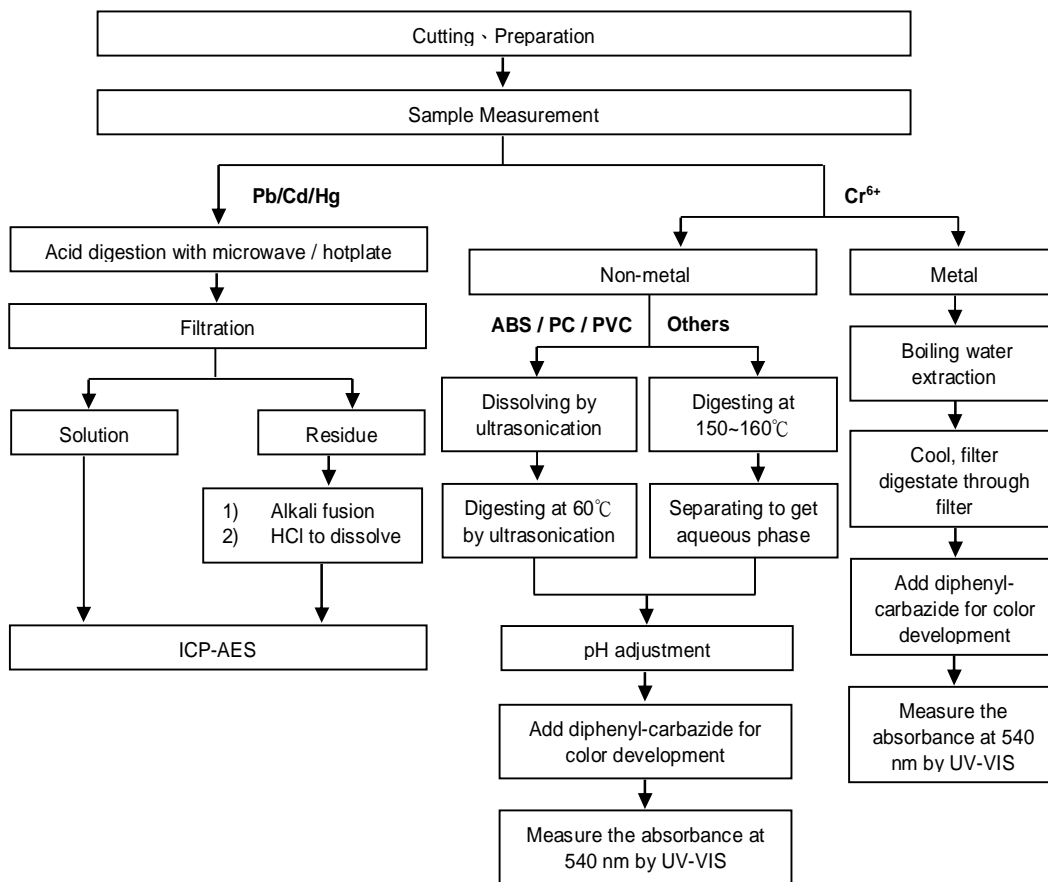
Analytical flow chart of Heavy Metal

These samples were dissolved totally by pre-conditioning method according to below flow chart. (Cr⁶⁺ test method excluded)

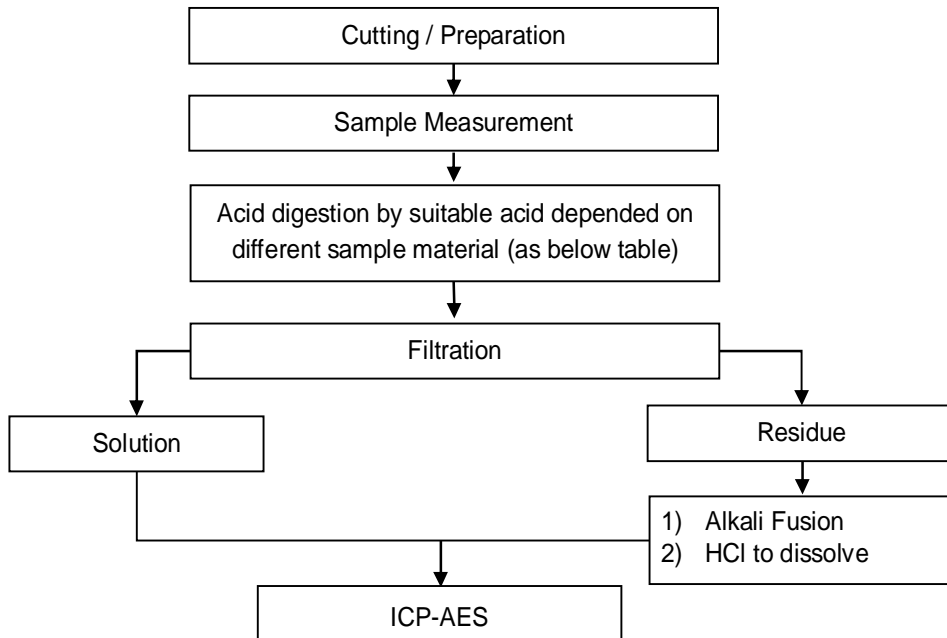
Flow Chart of digestion for the elements analysis performed by ICP-AES

These samples were dissolved totally by pre-conditioning method according to below flow chart.

Steel, copper, aluminum, solder	Aqua regia, HNO ₃ , HCl, HF, H ₂ O ₂
Glass	HNO ₃ /HF
Gold, platinum, palladium, ceramic	Aqua regia
Silver	HNO ₃
Plastic	H ₂ SO ₄ , H ₂ O ₂ , HNO ₃ , HCl
Others	Added appropriate reagent to total digestion

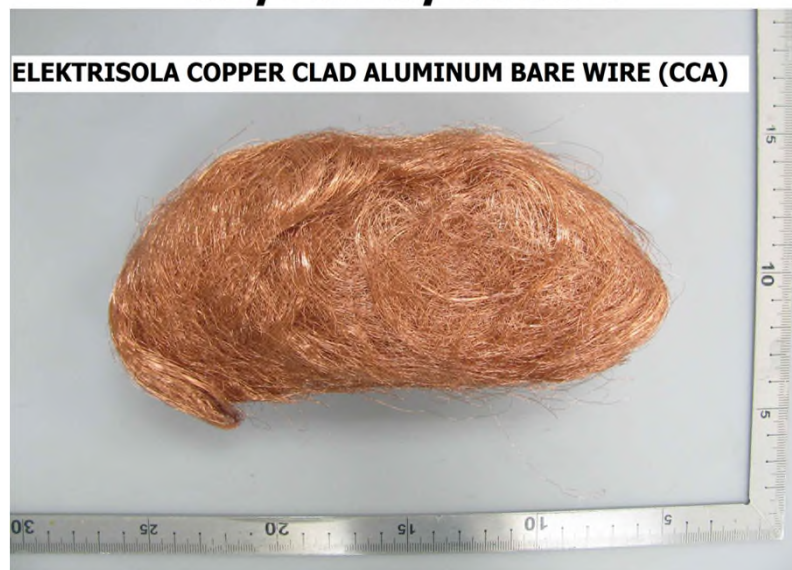
CE/2018/40394

* The tested sample / part is marked by an arrow if it's shown on the photo. *
