Test Report

No. : CE/2018/40393

Sample Submitted By : ELEKTRISOLA (MALAYSIA) SDN. BHD.
Sample Description : ELEKTRISOLA COPPER BARE WIRE (Cu)
Sample Receiving Date : 2018/04/02
Testing Period : 2018/04/02 TO 2018/04/13

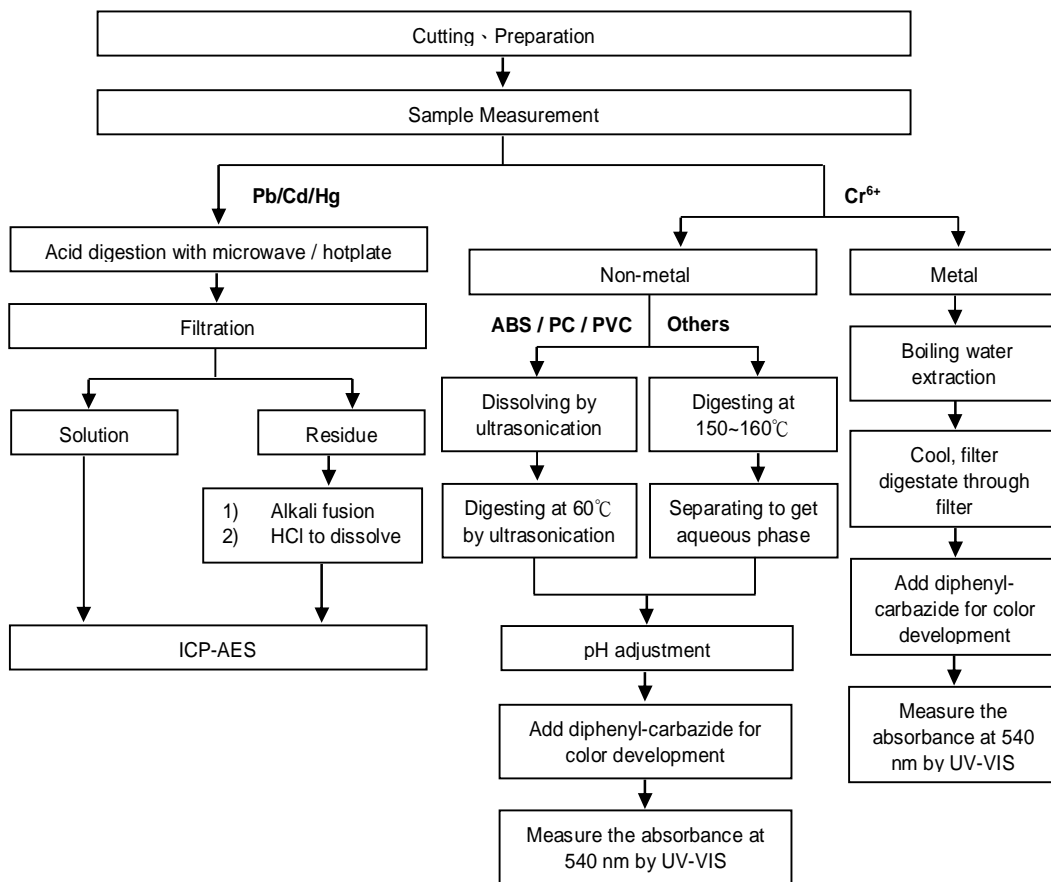
Analytical flow chart of Heavy Metal

These samples were dissolved totally by pre-conditioning method according to below flow chart. (Cr⁶⁺ test method excluded)

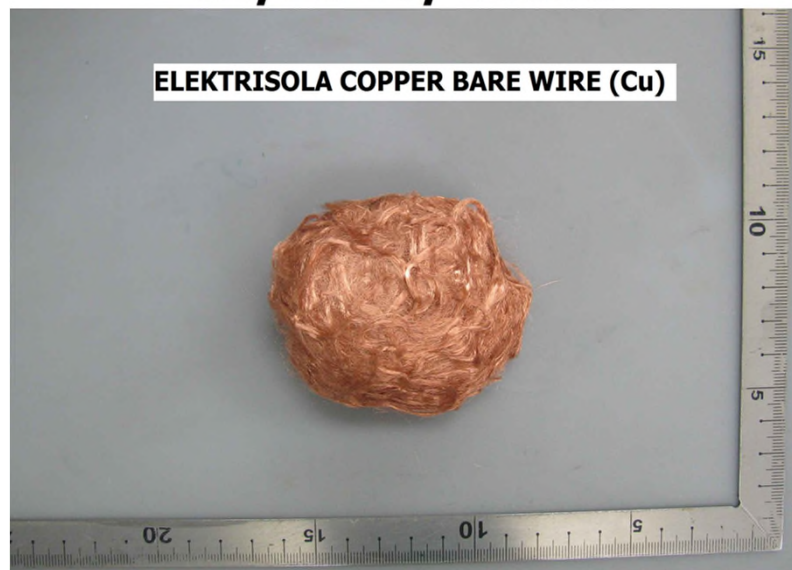
CE/2018/40393

* The tested sample / part is marked by an arrow if it's shown on the photo. *
