Test Report

No. : CE/2018/40396

Sample Submitted By : ELEKTRISOLA (MALAYSIA) SDN. BHD.
Sample Description : ELEKTRISOLA EXTREME HIGH TENSION BARE WIRE (EHTW)
Sample Receiving Date : 2018/04/02
Testing Period : 2018/04/02 TO 2018/04/13

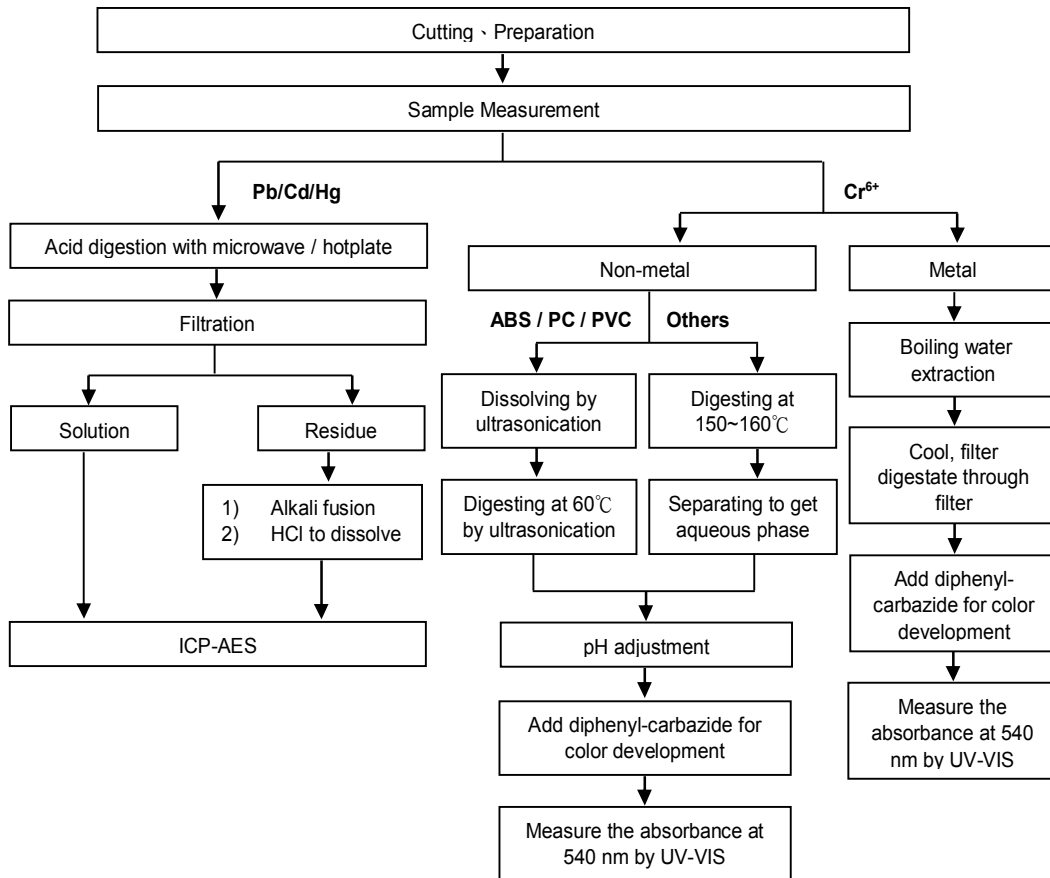
Analytical flow chart of Heavy Metal

These samples were dissolved totally by pre-conditioning method according to below flow chart. (Cr⁶⁺ test method excluded)

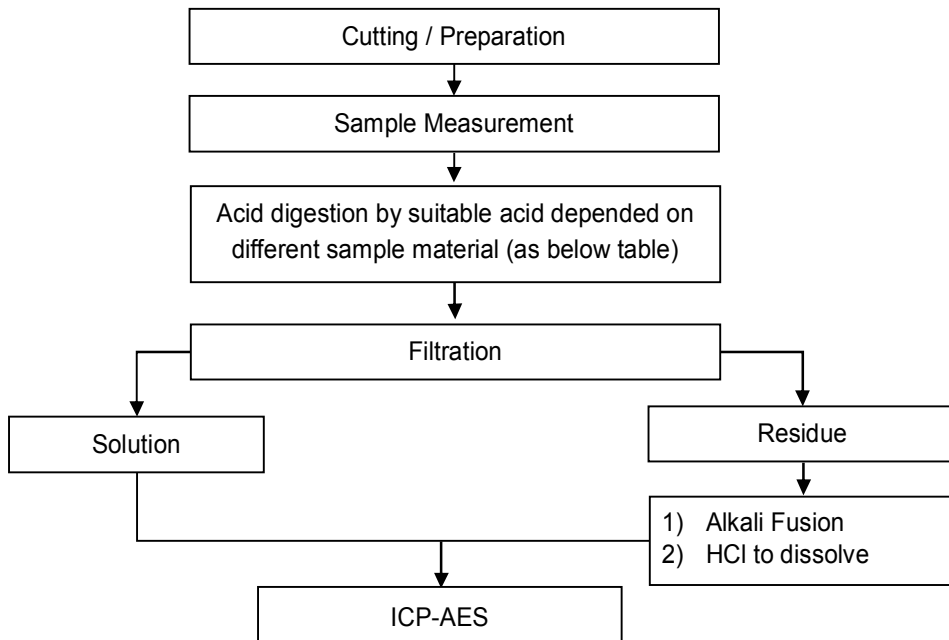
Flow Chart of digestion for the elements analysis performed by ICP-AES

These samples were dissolved totally by pre-conditioning method according to below flow chart.

Steel, copper, aluminum, solder	Aqua regia, HNO ₃ , HCl, HF, H ₂ O ₂
Glass	HNO ₃ /HF
Gold, platinum, palladium, ceramic	Aqua regia
Silver	HNO ₃
Plastic	H ₂ SO ₄ , H ₂ O ₂ , HNO ₃ , HCl
Others	Added appropriate reagent to total digestion

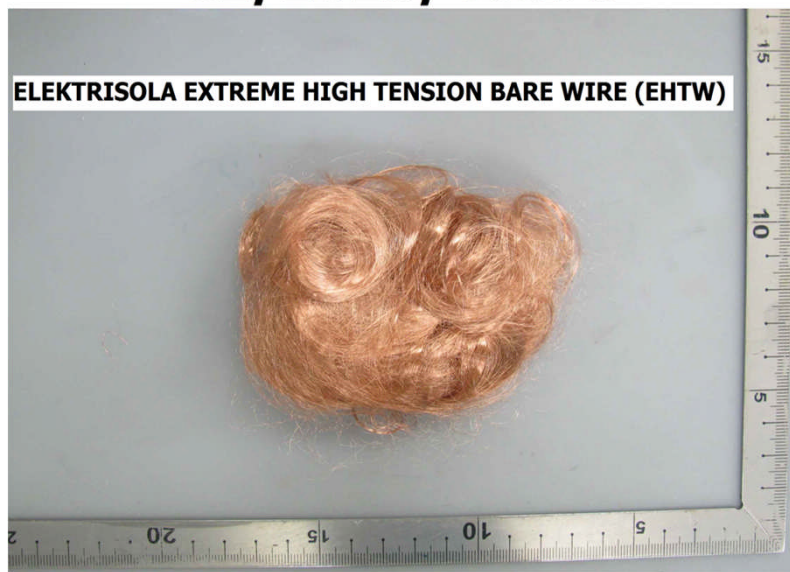
CE/2018/40396

* The tested sample / part is marked by an arrow if it's shown on the photo. *
