Test Report

No. : CE/2018/40398

Sample Submitted By : ELEKTRISOLA (MALAYSIA) SDN. BHD.
Sample Description : ELEKTRISOLA HIGH TENSION BARE WIRE (HTW)
Sample Receiving Date : 2018/04/02
Testing Period : 2018/04/02 TO 2018/04/13

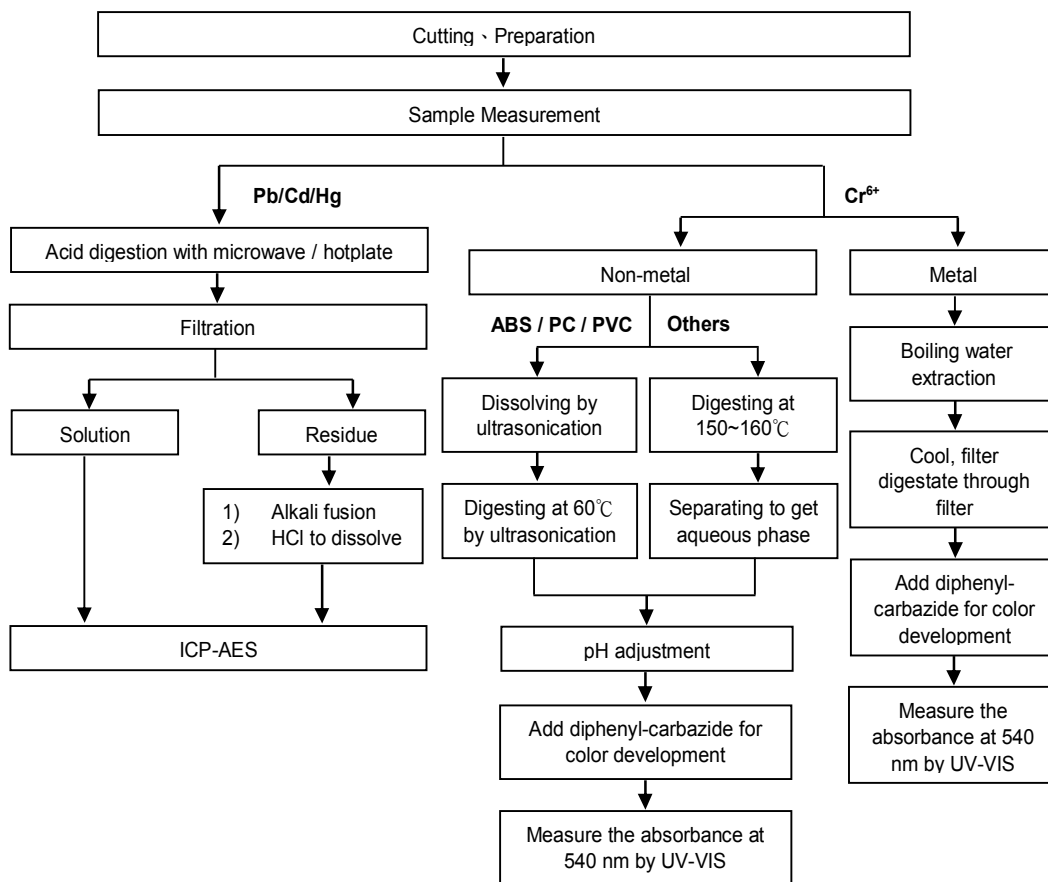
Analytical flow chart of Heavy Metal

These samples were dissolved totally by pre-conditioning method according to below flow chart. (Cr⁶⁺ test method excluded)

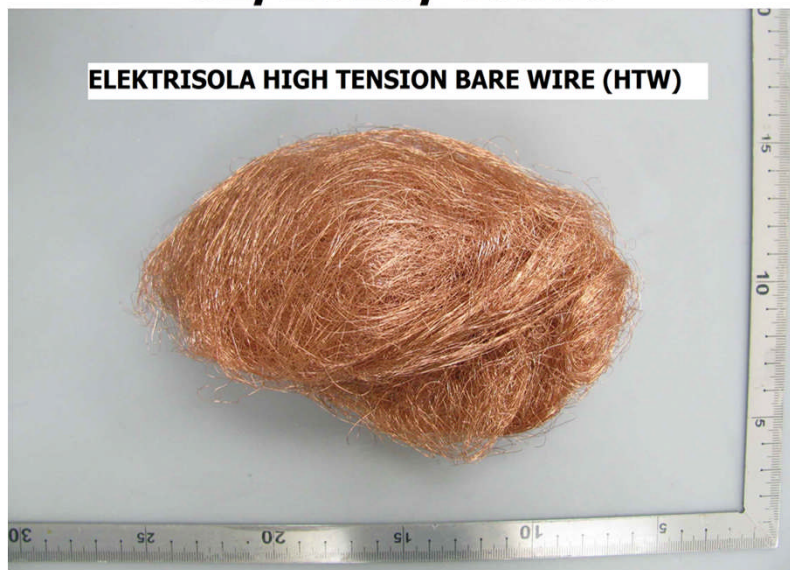
CE/2018/40398

* The tested sample / part is marked by an arrow if it's shown on the photo. *
