Test Report

No. : CE/2018/40399

Sample Submitted By : ELEKTRISOLA (MALAYSIA) SDN. BHD.
Sample Description : ELEKTRISOLA INCREASED COPPER CLAD ALUMINUM BARE WIRE (ICCA)
Sample Receiving Date : 2018/04/02
Testing Period : 2018/04/02 TO 2018/04/13

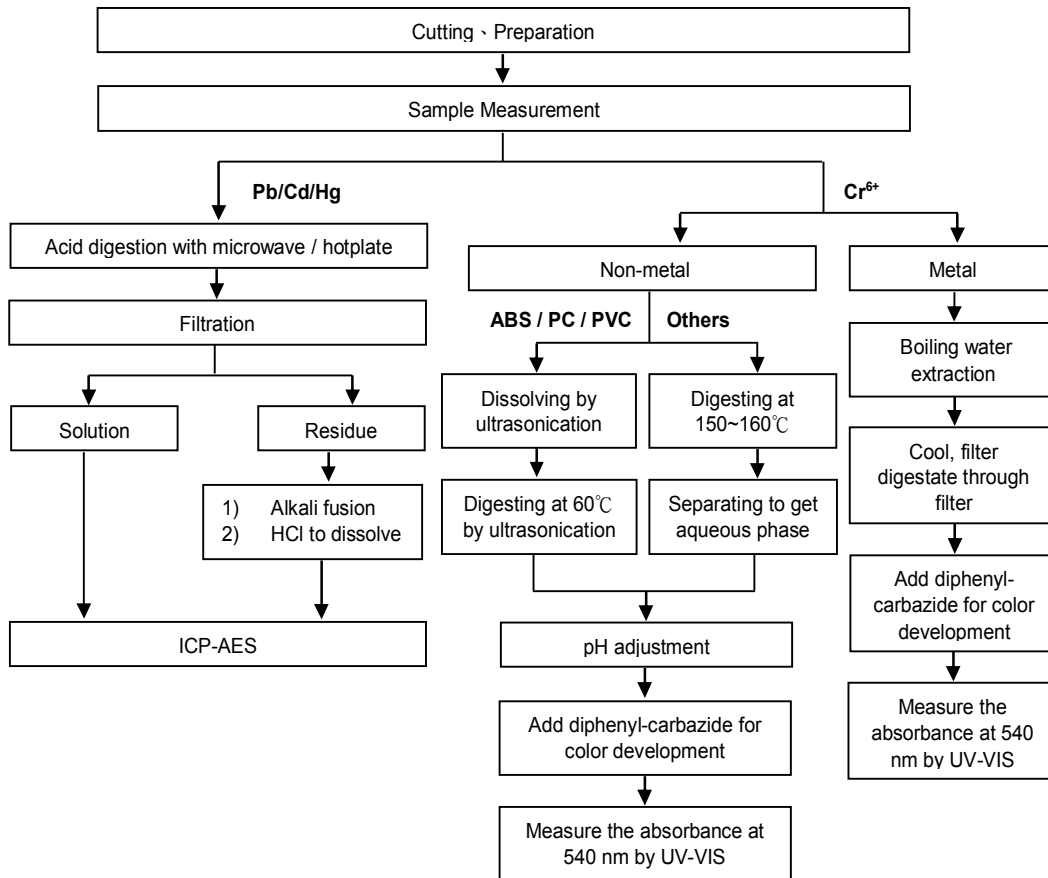
Analytical flow chart of Heavy Metal

These samples were dissolved totally by pre-conditioning method according to below flow chart. (Cr⁶⁺ test method excluded)
