Test Report

No. : CE/2018/40403

Sample Submitted By : ELEKTRISOLA (MALAYSIA) SDN. BHD.
Sample Description : ELEKTRISOLA EXTRA HIGH TENSION BARE WIRE (XHTW)
Sample Receiving Date : 2018/04/02
Testing Period : 2018/04/02 TO 2018/04/13

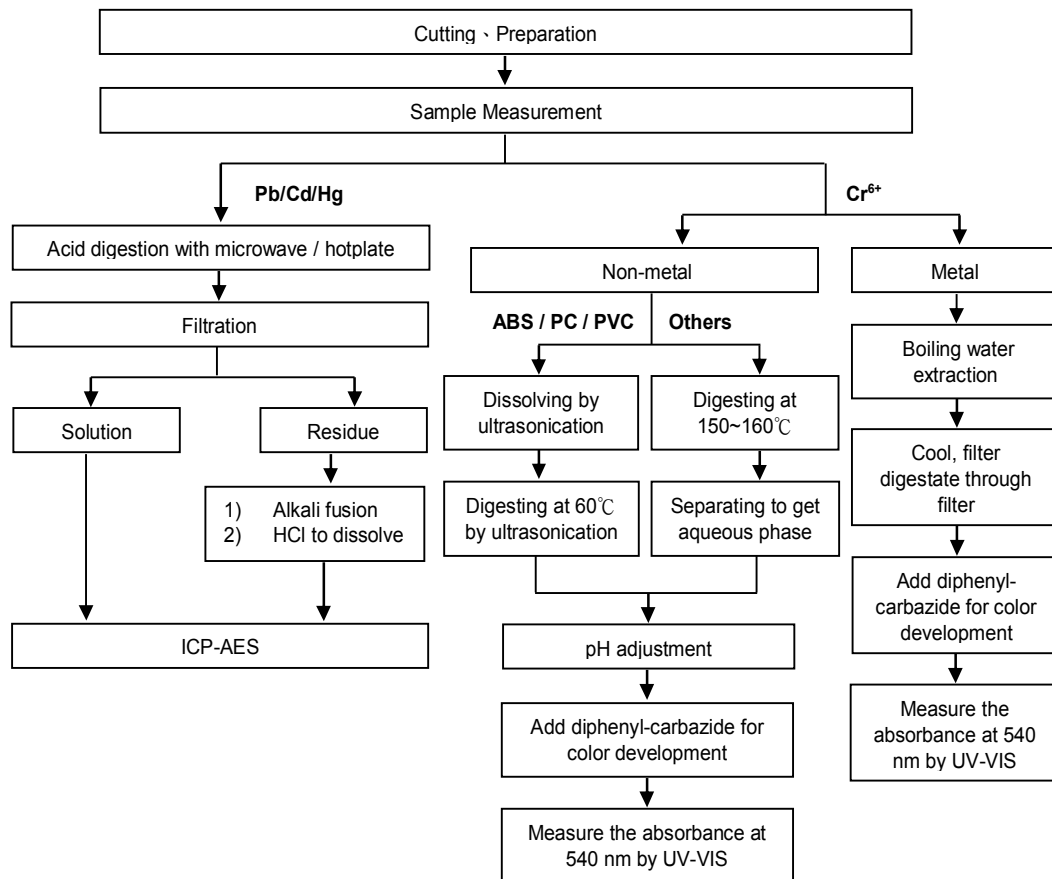
Analytical flow chart of Heavy Metal

These samples were dissolved totally by pre-conditioning method according to below flow chart. (Cr⁶⁺ test method excluded)

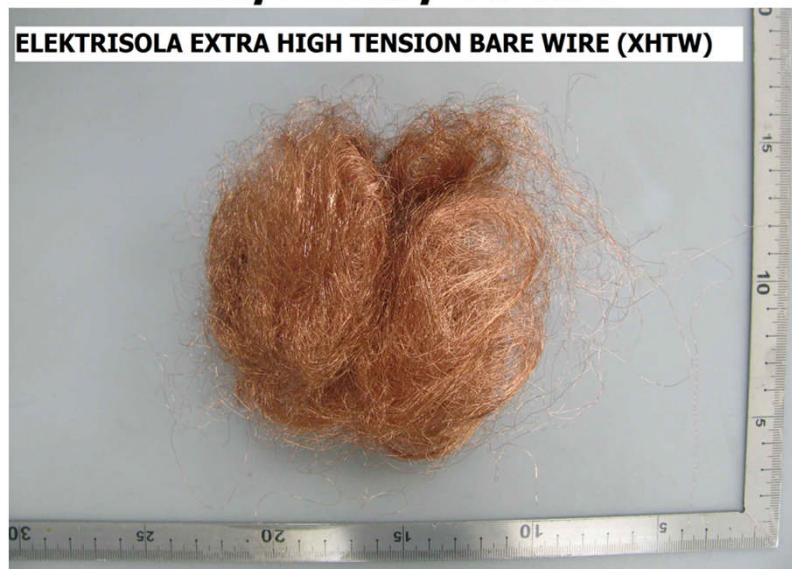
CE/2018/40403

* The tested sample / part is marked by an arrow if it's shown on the photo. *
